# **Implementation of Road Safety Audit to Highlight the Deformities in the Design and Environmental Safety Features: A Case Study on National Highway-326**

*“NH-326 from Km 212.700 to Km 253.700 Km and Km 281.700 to Km 311.700 (Old chainage 0/000 to Km 30/000 and from Km 58/0 to Km 99/0)”*

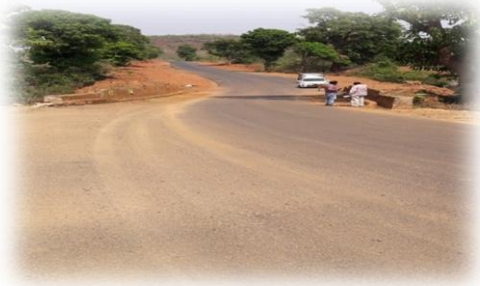
<b>Sl. No</b>	<b>Observation</b>	<b>Measures</b>	<b>Priority</b>
<b>1</b>	<b>Under-construction stage</b>		
<b>Case - I</b>	At chainage: 11/500Km, The road alignment is not safe for moving vehicles on design speed, because there is an “S” curve. As the culvert to be retained and the alignment is finalized. Both the entry and exit point of culvert should properly match with the transition of S curve.	➤ All the relevant sign boards, road marking, lighting, both side <b>(entry and exit of curves must provide ramblers)</b> , delineator, Hazard marker at CD and etc. should be provided as per guide line.	<b>Very much Essential</b>

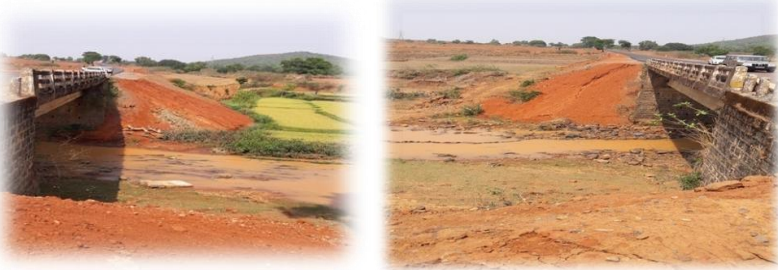
(Left Side View) (Right Side View)

<b>Case-2</b>	At chainage: 14/100km -14/200km, Bridge approach embankment slope is not the standard 2:1, embankment is not safe, soil erosion take places.	➤ There need protection wall at both side, the nallah bed sours present, so need ‘D’ wall for floor protection and nallah water way protection.	<b>Very much Essential</b>

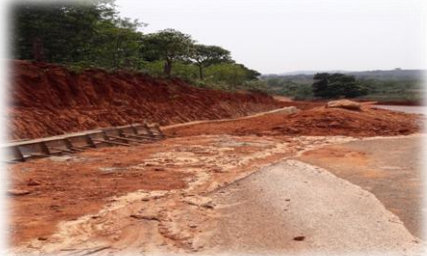
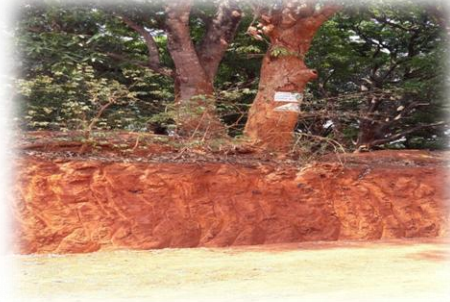
<b>Sl. No</b>	<b>Observation</b>	<b>Measures</b>	<b>Priority</b>
<b>Case - 3</b>	<p>At chainage km(21/800 -21/850), the road is constructed by cutting the road ways, the cutting is not maintaining slope 1:1, both side slope are vertical, so the embankment may falls at any time, both side edge bears trees it may fell down at any time.</p>

<p><i>(Right Side View)</i></p>	<p>➤ The slope should be maintained proper and check the stability of embankment, trees should be cut immediately. Breast wall on LHS around 50m length and RHS around 100m length need to be provided.</p>	<p><b>Very much Essential</b></p>
<b>4</b>	<p>At chainage 29/530km, Left side cutting slope is not maintained, it is almost vertical, Right side village road crossing, which is connects with a steeper gradient, and site distance is very poor.</p>	<p>➤ The junction need to develop properly and the cutting slope should be rectified</p>	<p><b>Very much Essential</b></p>

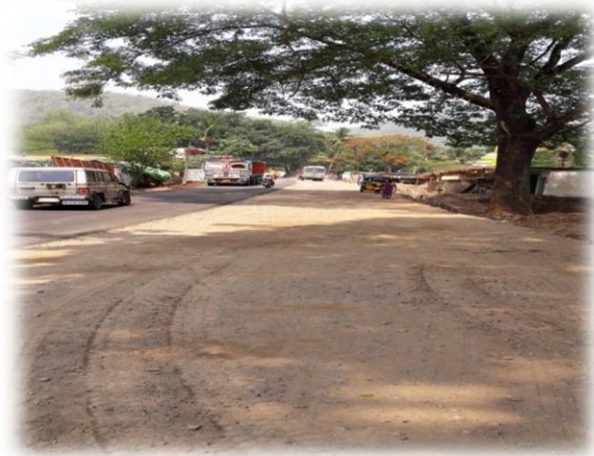
<b>9</b>	At chainage: 62/262 – 62/400 km High embankment need to provide safety barrier	➤ Both side of road edge need safety barrier by using guard post or metal beam crash barrier.	<b>Very much Essential</b>
<b>10</b>	At chainage: 68/496 km, Habitation area and School LHS precaution and safety information mandatory sign boards etc. are to be provided.	➤ All the relevant sign boards, road marking, lighting and rumbles as per guide line should be provided	<b>Very much Essential</b>
<b>11</b>	At chainage: 75/600 km, Habitation area Potali and School precaution and safety information mandatory sign boards etc. are to be provided. Here also horizontal curve site distance is obstructed.	➤ All the relevant sign boards, road marking, lighting, rumbles, reflector should be provided as per guide line.	<b>Very much Essential</b>

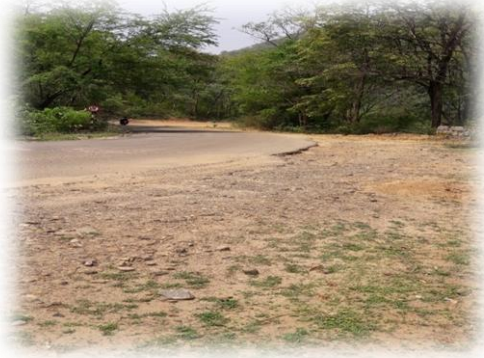
<b>Sl. No</b>	<b>Observation</b>	<b>Measures</b>	<b>Priority</b>
12	At chainage: km (88/5-88/800) 2 hair pin bends and from km(90/0-91/0) 3hair pin bends and steeper gradient, informatory signboards, safety barrier and guard wall, beast wall need to provide	➤ All the relevant sign boards for hair pin bend, steeper gradient incline/decline, curve sign, wild animal crossing, road marking, lighting, rumbles, reflector should be provided as per guide line.	<b>Very much Essential</b>

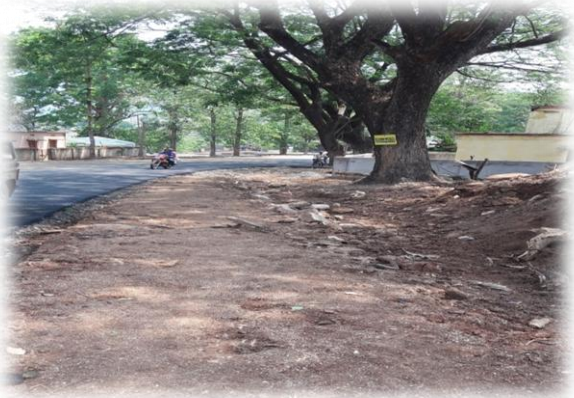
13	At chainage: 93/985 km, Habitation area, R.I office, Hospital, 5 big trees at curve location, horizontal site distance site distance is obstructed.	➤ All the relevant sign boards, road marking, lighting, rumbles, reflector less ribbons should be provided. Tree should be marked properly for alerting drivers.	<b>Very much Essential</b>

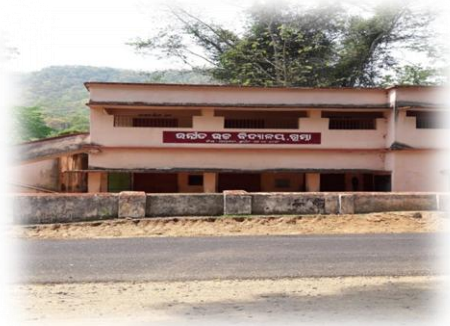
<b>Sl. No</b>	<b>Observation</b>	<b>Measures</b>	<b>Priority</b>
14	At chainage: 94/273 km, Habitation Guma School (RHS) precaution and safety information mandatory sign boards etc. are to be provided.	➤ All the relevant sign boards, road marking, lighting, rumbles should be provided as per guide line.	<b>Very much Essential</b>

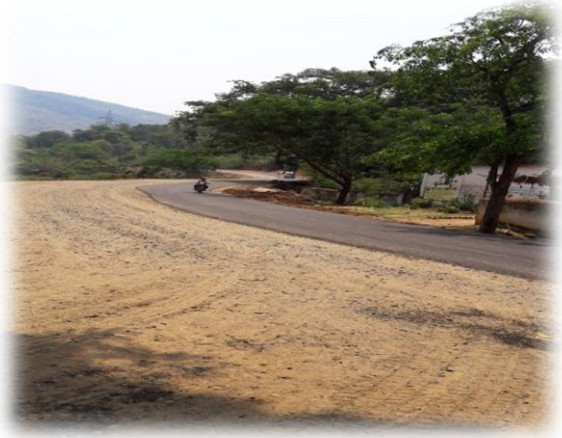
15	At Chainage: km (95/435 -95/487), No overtaking zones	➤ No overtaking zone sign and road marking, lighting etc. to be provided	<b>Very much Essential</b>
16	At chainage: km (95/990), 'S' CURVE	➤ Curve sign, no overtaking zone sign and road marking, lighting etc. to be provided, super elevation, extra widening , safety barrier at LHS to be provided	<b>Very much Essential</b>

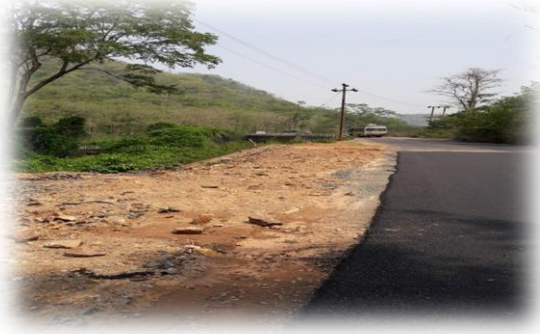
<b>Sl. No</b>	<b>Observation</b>	<b>Measures</b>	<b>Priority</b>
17	<p>At chainage: 96/790, Bridge 3x34.5, High embankment both side approaches need to provide safety barrier.</p>

<ul style="list-style-type: none"> <li>➤ Few guard post exists, which are quite insufficient for hazards, So both side approach needs to provide safety barrier by using guard post or metal beam crash barrier.</li> </ul>	<b>Very much Essential</b>
18	<p>At chainage: 97/000km, MB 7x9x4.2m, High embankment both side approaches need to provide safety barrier and protection to the embankment. Right side Hill, Horizontal curve affected with site distance.</p>

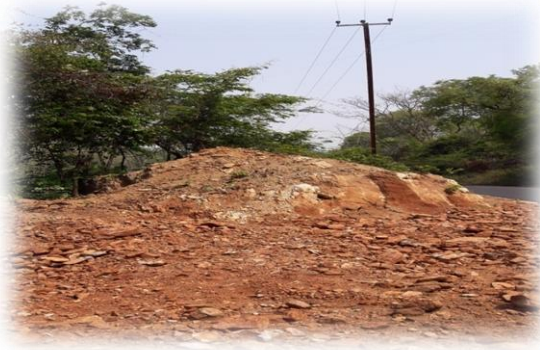
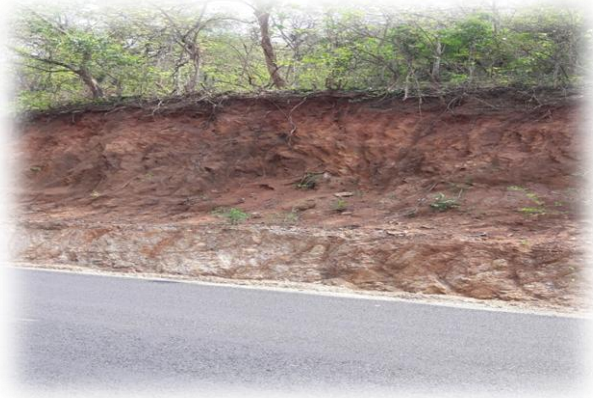
<ul style="list-style-type: none"> <li>➤ Both side approach needs to provide safety barrier by using guard post or metal beam crash barrier, the high embankment should be protected with PCC/RCC concrete wall. Hill side may be protected with breast wall. Clearing the hip and ground for clear site distance needed.</li> </ul>	<b>Very much Essential</b>

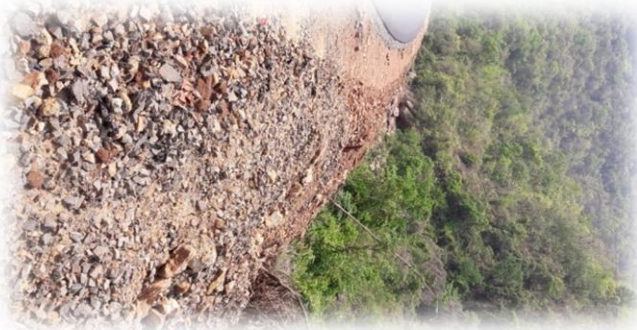
<b>RHS View</b>		
19	At chainage: km (97/968), Sharpe CURVE, site distance obstructed, LHS Temple, RHS Reserve forest.	➤ Curve sign, no overtaking zone sign, Loose gravel falling symbol and road marking, lighting etc. to be provided, super elevation, extra widening , safety barrier at LHS to be provided	<b>Very much Essential</b>
20	At chainage: km 98/468 horizontal curve, vegetation affected the site distance.	➤ Curve sign, road marking, lighting etc. to be provided, site distance affected by the vegetation need to be clear.	<b>Very much Essential</b>

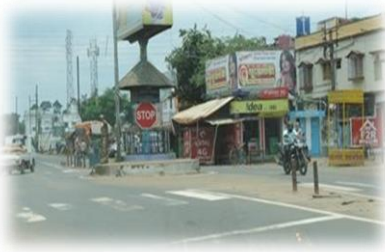
<b>4.</b>	<b>Road Crash Black Spot Analysis</b>		
<b>4.1</b>	<b>*Built up area</b> School/Aganawadi / Hospital/ Bank Km. 1/0-1/2 , 2/080, 2/830 , 58/0 -58/300, 58/550 – 58/880, 60/500 – 60/700, 60/800-61/000, 62/600-62/880, 69/200 – 69/500, 75/600 – 75/800, 82/700 – 82/800, 83/100-83/300, 93/900 -94/300	➤ Pedestrian crossing and side walk facilities at the intersection need to be created. Also consider painting the Road markings on all minor roads indicating the pedestrian crossings and road openings with dotted line coupled with the provision of STOP line marking on the intersecting road. ➤ Proper signage is to be erected at least 100 mtr ahead of the these area ➤ road marking, Zebra crossing ➤ Rambler strip and delineator to be provided	<b>Essential</b>

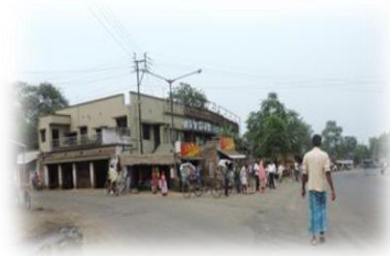
<p><b>*Major Junctions</b>                      0/0km, 0/330, 77/800</p>	<ul style="list-style-type: none"> <li>➤ Pedestrian crossing and side walk facilities at the intersection need to be created. Also consider painting the Road markings on all minor/major roads indicating the pedestrian crossings and road openings with dotted line coupled with the provision of STOP line marking on the intersecting road.</li> <li>➤ Junction need to develop properly and the grades of the junctions and merging point should be as per code provision.</li> <li>➤ Proper signage is to be erected at least 100mtr ahead of the these area</li> <li>➤ road marking, Rambler strip and delineator to be provided</li> </ul>
